PORSCHE

# **Service Information**

Technical Bulletins

January 1987 - December 1987

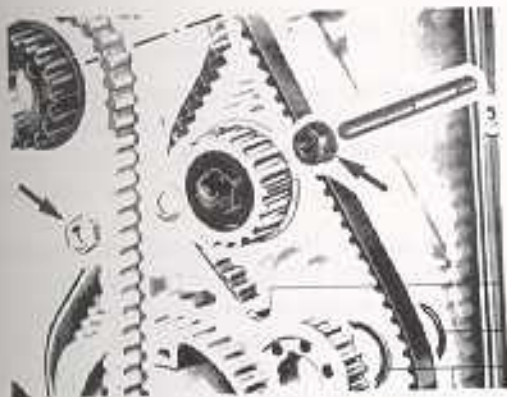
Failure to ensure proper torque of these nuts may cause breakage of the tensioning roller stud and result in severe engine damage.

When making repairs or adjustments to the camshaft drive belt, be certain to torque the retaining nut of the tensioning roller and the shouldered nut behind the tensioning roller (arrows) to 45 Nm (32.4 ft. lbs.)

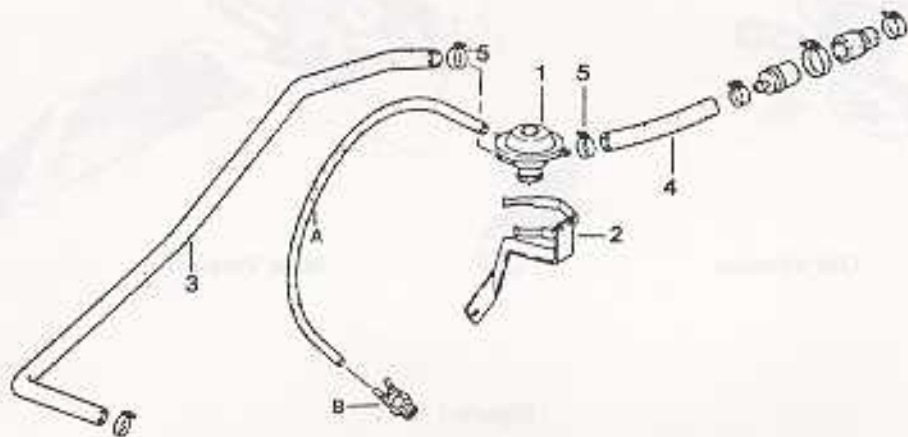
Figure II

Incorrect vacuum hose connection on temperature switch (B in Figure II) can cause rattling noise. Angled connection of temperature switch connects to vacuum source and straight connection to air valve.

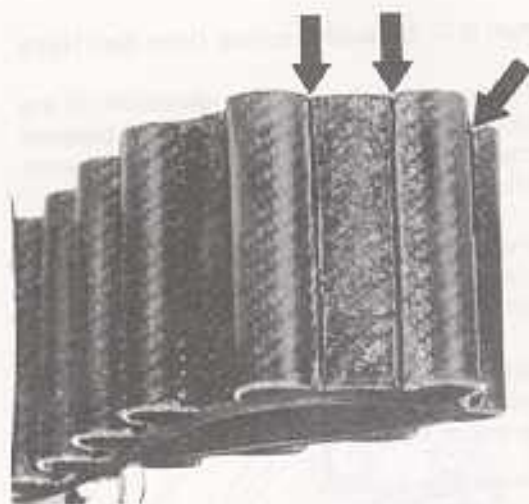
Figure 1

Condition: Cracks at base of teeth.

Cause: Improper (too loose) belt tension.

Remarks: With belt installed, this condition is not easily seen. Bend the belt outward or if removed, bend belt as shown in photo. Use caution not to kink belt.

Correction: Replace belt and set to correct tension.

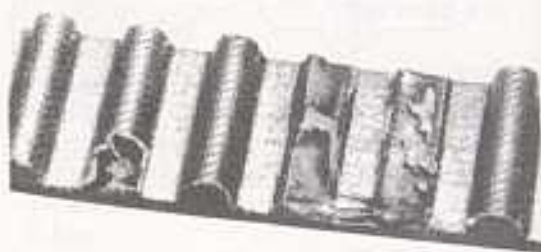
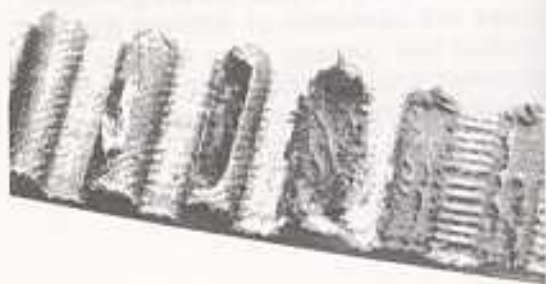
Figure 2

Condition: One or more teeth cracked or broken. Teeth may be partially or completely broken out.

Correction: Replace belt and set to correct tension. Check for and remove foreign objects and replace damaged gear wheels or seized belt tensioning roller.

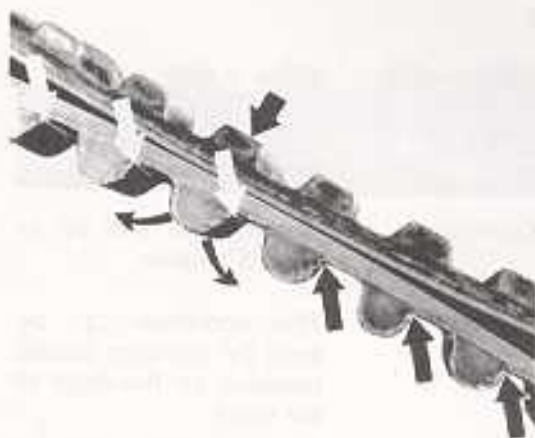
Figure 3

**Remarks:** By applying thumb pressure on the teeth in the direction of curved arrows, the base cracks can be more easily detected.

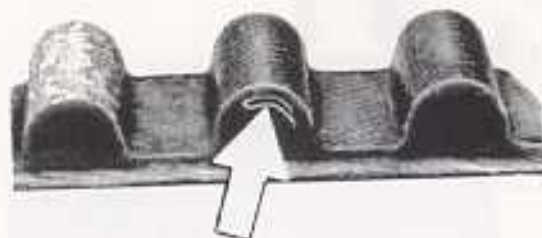
Figure 5

Remarks: This condition can be seen by applying thumb pressure on the edge of the tooth.

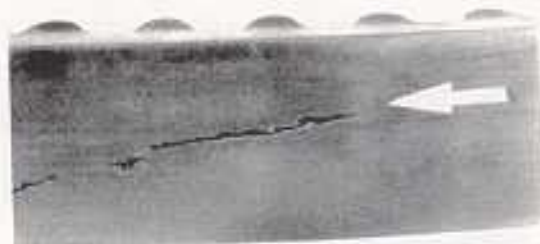
Figure 6

Condition: Mechanical damage to the backing of the toothed belt. This condition can also occur on the edge of the belt.  
Cause: Foreign objects.  
Correction: Check for and remove foreign objects, replace belt, and set to correct tension.

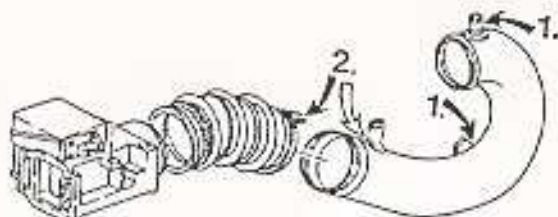
When repairing high idle or low CO% conditions on 944S cars, first check the intake air bellows and connecting pipe for leaks. Be certain all hose connections (arrow 1) on the connecting pipe and air bellows are not damaged, swollen or cracked.

When replacing, only improved version parts are available. The air bellows received an installation guide (arrow 2) and the connecting pipe ends were reinforced with metal sleeves.
