PORSCHE

Service Information

Technical Bulletins

January 1988 - December 1988

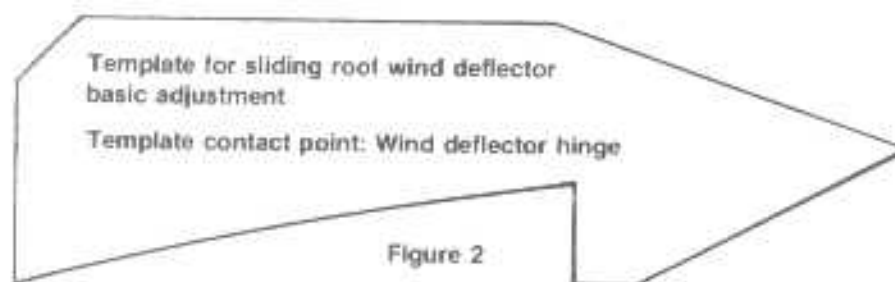
Figure 1

The sliding roof wind deflector angle is adjustable with two screws (Figure 1) to minimize wind noise.

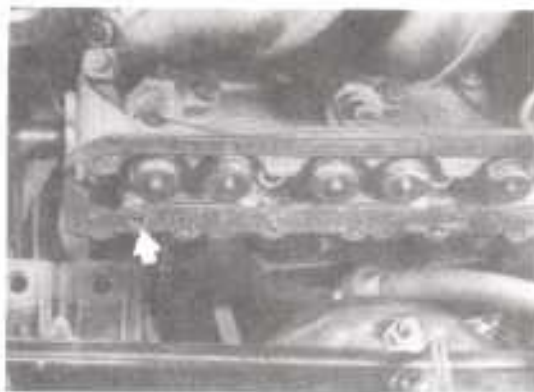
When installing the cam housing gasket, be certain the oil feed hole of the gasket (arrow) is correctly positioned over the oil check valve bore. In some instances the words "oben-top" may not be on the correct side of the gasket. This could lead to improper installation resulting in lack of lubrication to the camshaft and related parts. If the "oben-top" indication is found to be incorrect, turn the gasket over to correctly align the oil bore. Either side of the gasket can mate with the cylinder head or cam housing.

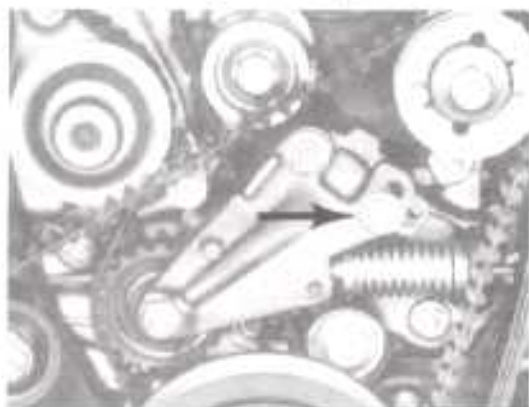
The material of the mechanical camshaft belt tensioner has been changed from cast iron to aluminum. The new aluminum tensioner also has a formed washer (arrow) in the area of the elongated bolt hole, to prevent damage to the aluminum housing when tightening.

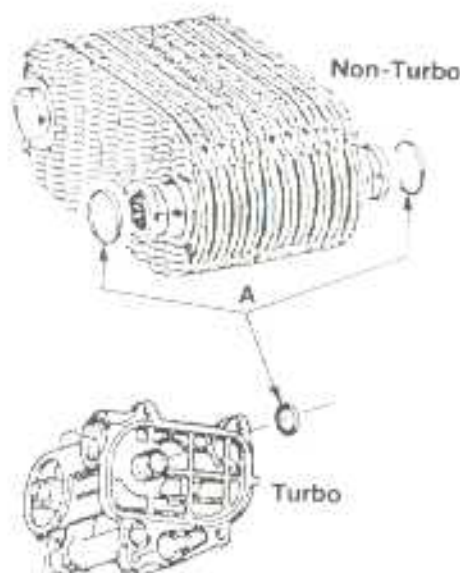
Figure 1

The sealing O-rings (A, figure 1) located on the oil cooler of normally aspirated cars and on the connecting pipe of the oil thermostat housing of Turbo cars, have been changed. The new version O-ring is now green in color (formerly red). When repairing, use ONLY the new version green O-rings.
Part Number 999 707 043 40.

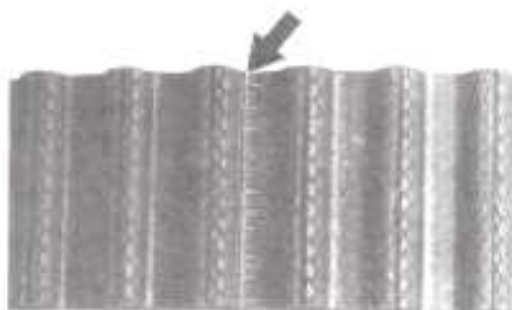
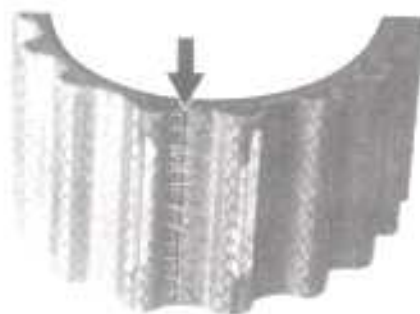
The new camshaft drive belt,
PN 944 105 323 00
from Pirelli, can have visible seams (arrows)
in the web/tooth base area:

These seams are a result of the manufacturing process, and must not be mistaken for damage type "cracks at base of teeth" as shown on page 4, example 1, of Technical Bulletin Group 1, Number 8715, Book D, page 60. These production seams have no effect on the service life of the belt.
