**TECHNICAL BULLETINS**  
**JANUARY 1989 - DECEMBER 1989**

**SERVICE INFORMATION**  
PORSCHE CARS NORTH AMERICA, INC.

<b>Technical Bulletin</b>	<b>Model</b> 928 S4, 944S	<b>Group</b> 0
	<b>Part Identifier</b> 0300	<b>Number</b> 8901

**Subject: Performing System Adaption If Battery was Disconnected**

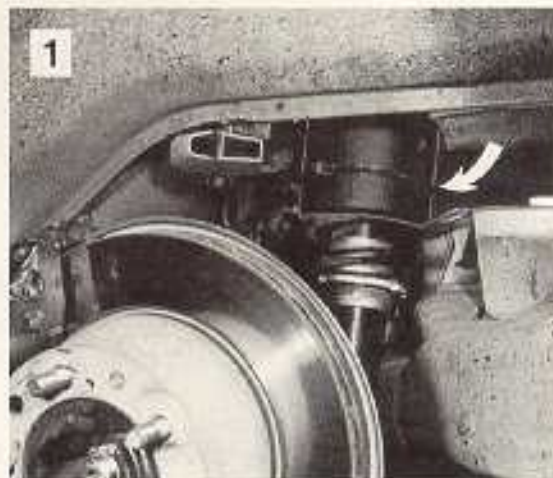
Figure 1

The spring blocks (Figure 1) and transportation hooks (Figure 2) must be removed after the dealer receives the car.

Driving a car with spring blocks and/or transportation hooks still installed impairs handling and operating safety.

- lift car on hoist, do not remove wheels.
- cut nylon strap (arrow in Figure 1) and remove spring blocks.
- remove transportation hooks (arrow in Figure 2) and close the threaded holes using the plugs supplied with the vehicle.

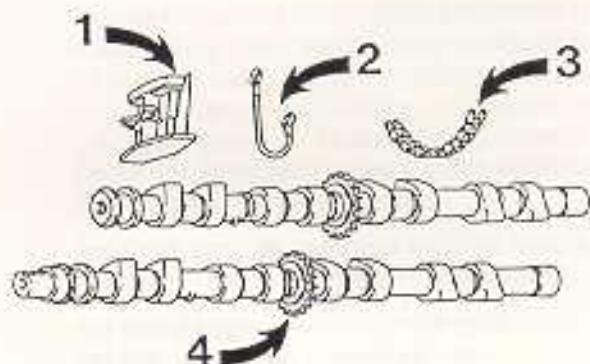
Arrow 4— Camshaft gear teeth:

Carefully inspect teeth of camshaft gears for wear or cracks.

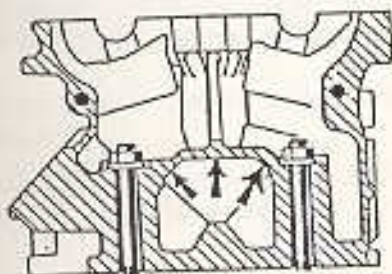
944S 87-88 Models  
2.5 liter Engine

Loss of coolant or coolant in the engine oil may, among other reasons, be caused by cracks in the cylinder head cooling jacket. These cracks may begin in the area of the exhaust valve and extend toward the cylinder head mounting bolt holes. The following figures show possible fracture locations.

If coolant loss with no visible external leaks is found, the cylinder head should be checked. To test an installed cylinder head, remove the cylinder head cover and apply 1 bar maximum (14.7 psi) pressure to the cooling system. Check for leakage of coolant in the areas of the arrows and/or pressure loss.

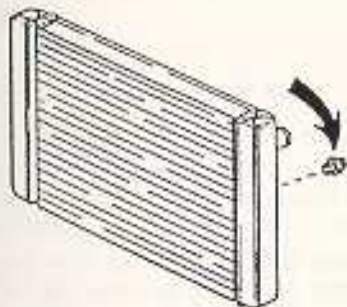
High engine temperature gauge readings (upper third of gauge) can be caused by a fan switch which switches at a higher temperature than desired. Improved switches are installed as of Model 89. They can be identified by a production date of 2/8 (Feb. 88) stamped on the switch housing.

Radiator fan switches with a production date prior to 2/8 (Feb. 1988) should not be used.

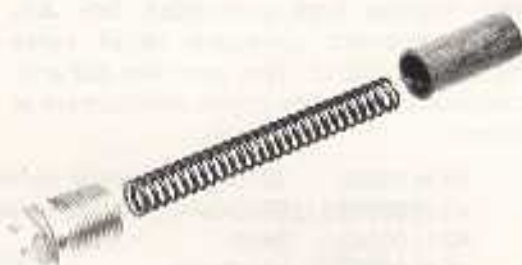
Figure 1

Up to and including 1986 Model Year  
original equipment.  
Three piece oil pressure relief valve.

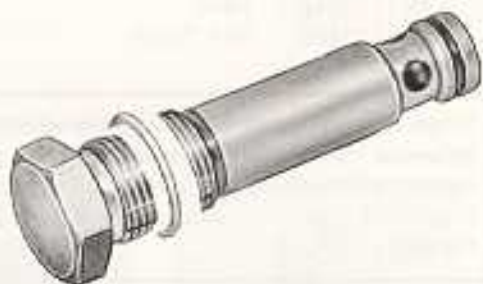
Figure 2

From July 1986 (1987 Model year).  
One piece oil pressure relief valve.

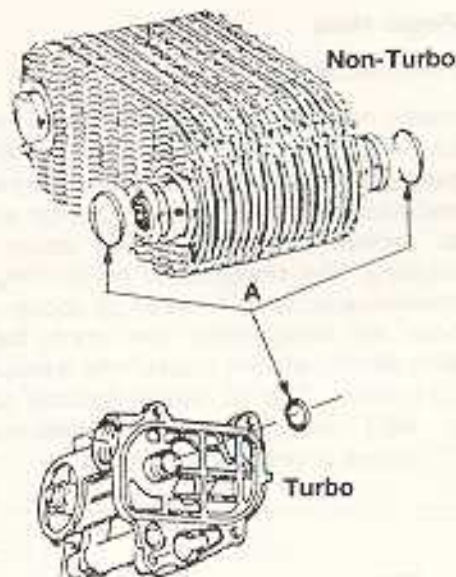
Figure 1

To determine if the oil cooler housing is the latest version, and to help prevent needless housing replacement, inspect as shown.

The sealing O-rings (A, figure 1) located on the oil cooler of normally aspirated cars and on the connecting pipe of the oil thermostat housing of Turbo cars, have been changed. The new version O-ring is now green in color (formerly red). When repairing, use ONLY the new version green O-rings PN 999 707 043 40.

When repairing earlier cars, the new type housing, plastic washer, and adjusting shims must be used.

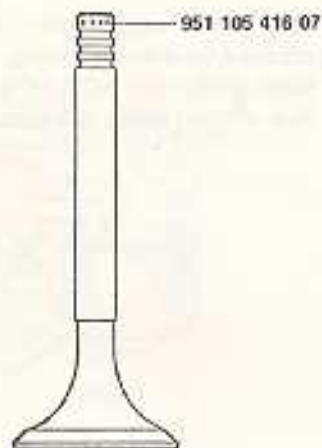
Figure 1

Prolonged high speed operation has caused seizing of exhaust valves in their guides in some countries other than the U.S. To reduce the possibility of this occurring, exhaust valves with a conical stem (0.01mm) and modified valve stem seals are installed in all 1988 model 944 Turbo S and 1989 model 944 Turbos including those for the U.S.

If, upon inspection, the hydraulic valve lifter is found to be disassembled, the exhaust valve may have seized. If it is suspected that a valve may have seized, the following parts must be replaced:

- exhaust valve
- valve stem seal
- hydraulic lifter
- valve spring set
- upper spring retainer
- valve keepers

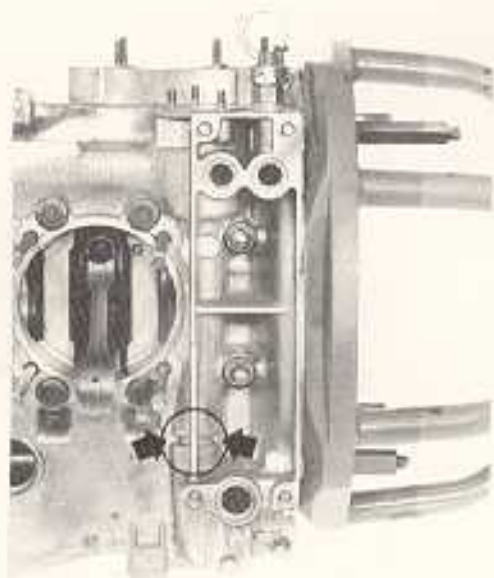
Figure 1

Oil leaks from the cast-in oil pipe in the right crankcase half (oil cooler area, Figure 1) can be repaired with engine removed or installed.

- Remove oil cooler
- Clean and degrease the crankcase thoroughly in the area of the pipe (circle in Figure 1) using acetone, alcohol or something similar.
- Apply a coat of Silastic 732 RTV sealing compound (Porsche PN 999 915 451 40) with light pressure uniformly until the depression (arrows in Figure 1) is filled. Smooth over the protruding sealing compound with a water coated putty knife or similar tool. Smoothing the compound is possible for a maximum of 5 minutes after application. Complete hardening time is 24 hours. Test running the engine will not disturb the hardening process.

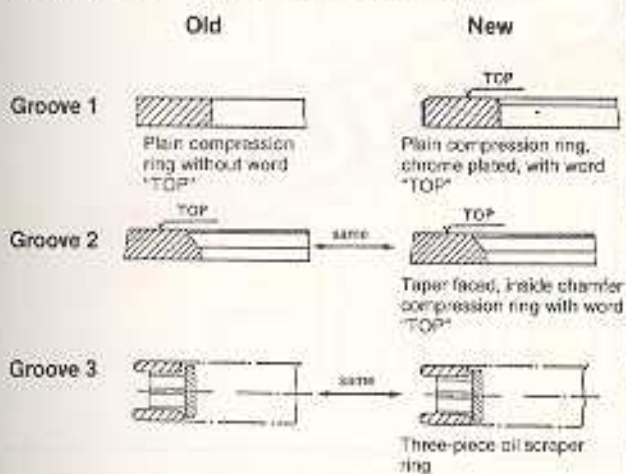
Figure 1

In production a three piece oil scraper ring is installed. Repair sets contain a bevelled edge ring with internal spring (Figure 1 and 2).

- Replace not only the piston rings, but also the pistons, in case of a complaint of "excessive oil consumption" from engines with a total operation of more than 40,000 miles.  
This is necessary because of wear in the groove flanks of pistons. This wear cannot be determined with common workshop equipment and will continue to cause excessive oil consumption even after installation of new piston rings.
- Connecting rod bearing shells must always be replaced when repairing an engine, for which it is necessary to remove the connecting rods.

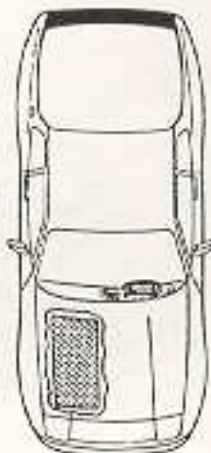
The spark plug wires may touch the engine hood which could result in an engine miss. To prevent this, an insulation piece PN 944 556 772 01 can be installed.

Position the insulation piece on the right inside of the engine hood as shown.

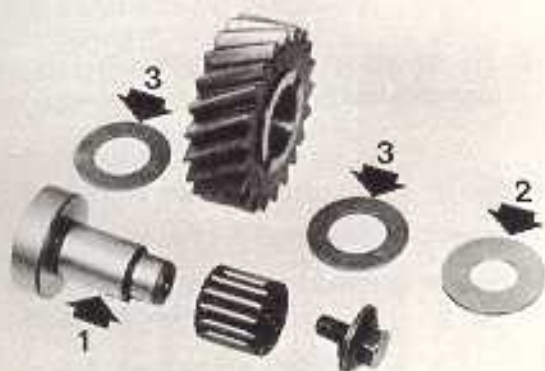
Reverse idler shaft: PN 950 302 228 03 (arrow 1)  
1 thrust washer: PN 950 302 297 10 (arrow 2)  
2 thrust washers: PN 950 302 297 12 (arrows 3)

The early version idler shaft PN 950 302 228 02 must no longer be used.

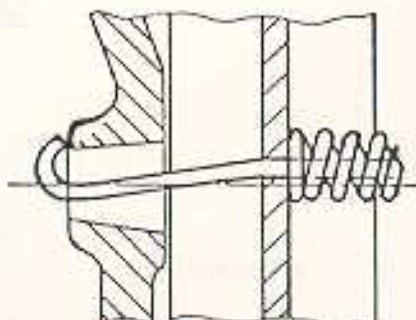
Incorrect  
Figure 2

Incorrect installation (Figure 2) will result in breakage of the retaining spring and possible damage to the brake shoes and related components, which is not a warranty matter.

**Repair Procedure:** When installing hand brake shoes, be certain to correctly position the brake shoe retaining spring (Figure 1).

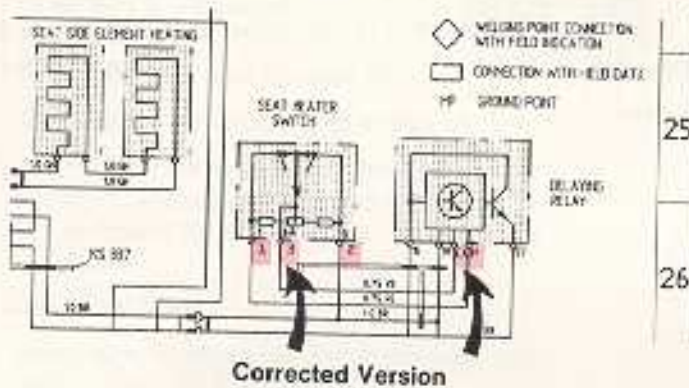
### 4 cyl. cars wiring diagram Sheet 6, Coordinates O,P 26

The terminal designations for the seat heating delaying relay and the seat heating switch (4 and 8 cyl. only) are incorrect on the 1989 Wiring Diagrams. Please update your wiring diagrams as follows:

Delaying Relay Terminal E change to P  
 P change to EA  
 Seat Heater Switch Terminal E change to 1  
 P change to 3  
 A change to 2
