PORSCHE

# **Service Information**

Technical Bulletins

January 1987 - December 1987

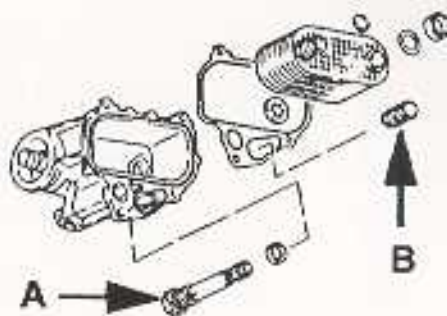
When repairs are made to the oil cooler or for oil pressure related problems, new oil pressure relief valve (Arrow A) Part Number 944 107 035 11 should be installed. This part will retrofit into all 944 engines from beginning of production 1983 through '86 models. It is important that the sleeve (Arrow B) be firmly installed in the crankcase. In addition, the oil cooler housing must be properly centered. Check with special tool P-9215 Part Number 000 721 921 50 and adjust if necessary.

Some 924S (early production cars) will have the former version piston and spring installed. When repairing them, the above mentioned valve should also be used.

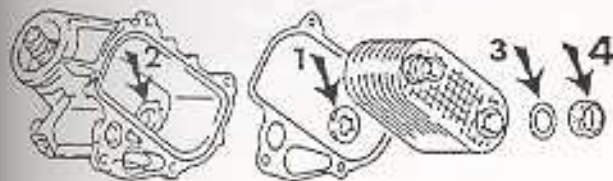
The oil cooler mounting was modified as follows:

1. Plastic washer installed between housing and oil cooler.
2. Housing - Guide drilling reworked.
3. Adjustment shims between cooler and crankcase installed.
4. Rubber ring - Always replace.

When repairing leaks or replacing the oil cooler on older cars, the new housing, plastic washer and adjusting shims have to be installed.

In case of leaks at the oil cooler, the cooling system needs to be flushed. The connecting rod bearings should be checked for wear if engine oil level was below "minimum" or if coolant entered the engine lubrication system.

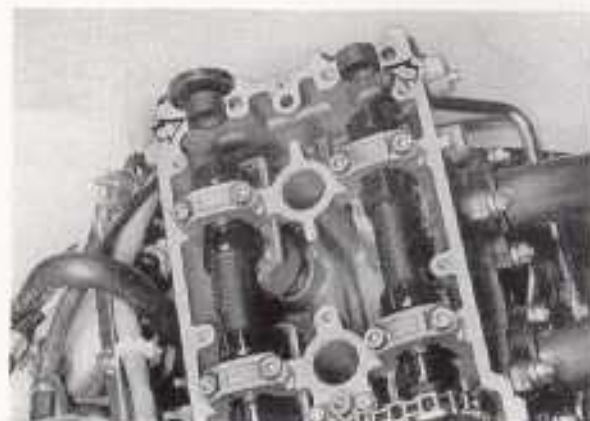
The camshaft bearing sealing washers (picture) on the 1987 Model 928 S4 with short camshafts received a longer guide pin to improve sealing and to prevent excessive oil from entering the camshaft housings.

New sealing washer Part Number:  
928 105 261 02

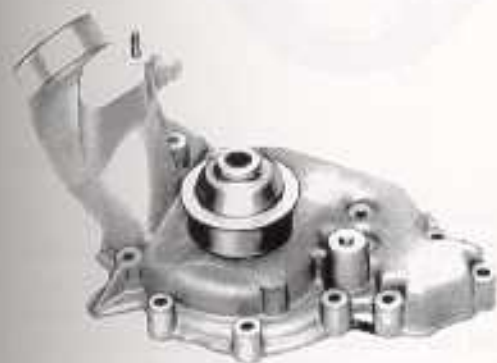
Old

This new version pump has modifications to the seals and pump body in the area of the vent bore (Arrow A). In addition, a guard rail (Arrow B) is installed and the toothed belt roller (Arrow C) is offset to guide the toothed belt.

When repairing cars from start of production 1983, install the new version coolant pump. The following parts must also be ordered for use with the new version coolant pump: (The following parts may or may not come with the new pump).

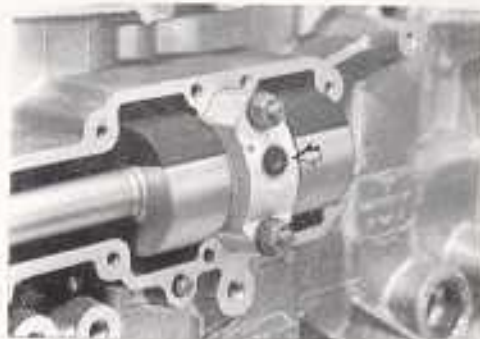
O-Ring Part Number 951 107 241 02.

When replacing turbo chargers on 1986 models where the turbine bearings are worn, the turbo charger outer oil supply side O Ring, located in the left side balance shaft cover, must also be replaced. Swelling of this O Ring could seriously impair flow of oil to the turbo charger. It must also be replaced whenever the balance shaft cover is removed for other repairs.

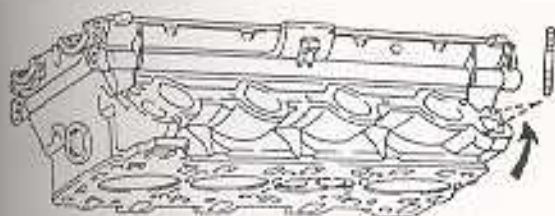
The water outlet flange connection at the rear of the cylinder head has been changed. Two M8x16 studs (arrow) are now installed and cemented into the cylinder head. They replace the 2 Fillister head bolts used previously.

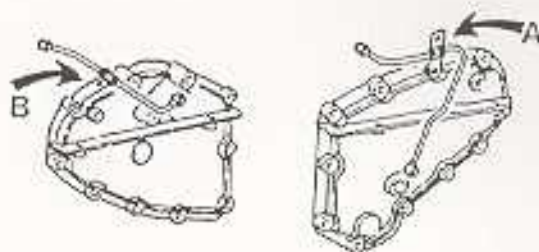
The right chain tensioner oil supply line was modified and the right and left oil supply lines are installed with an additional bracket on the chain housing cover. (Arrows in picture).

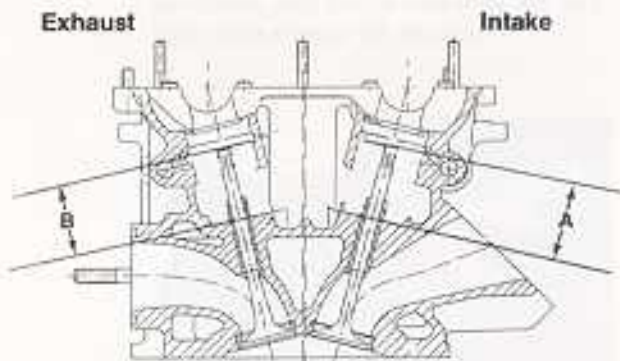
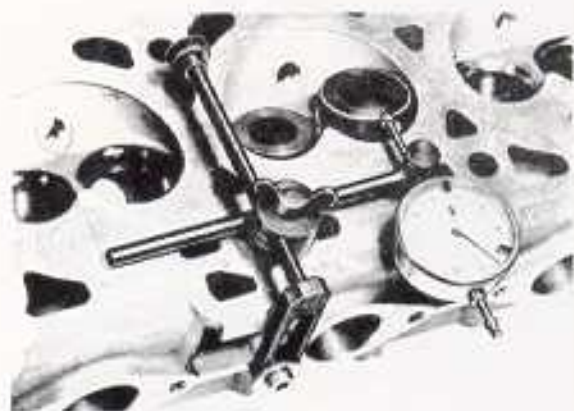
**Checking Valve Guide for Wear**

Wear limit 0.8mm for 2 valve and 4 valve engines measured with a new valve.

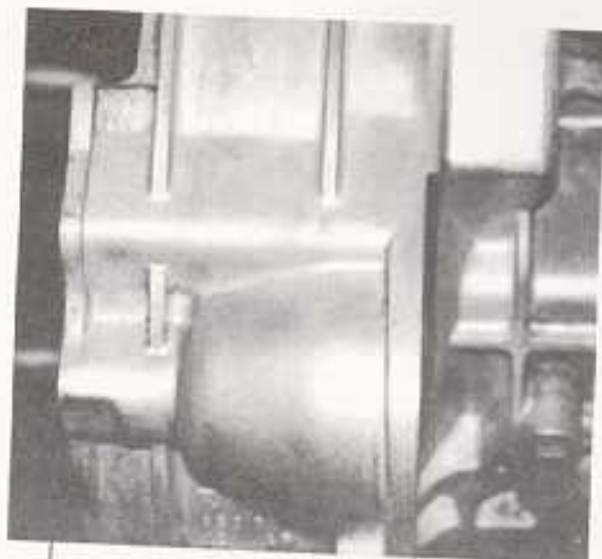
Subject: Starter Motor/Gear Damage

To assure good starter engagement, the engine mounting flange/starter motor mounting flange dimension on the 1987 Model 911 Carrera transmission housing was reduced from 117 - 0.2mm to 115 - 0.2mm (see picture).

When replacing starter motors with gear damage, the starter ring gear should also be checked for damage and replaced if necessary. Transmission dimension "a" should also be checked.

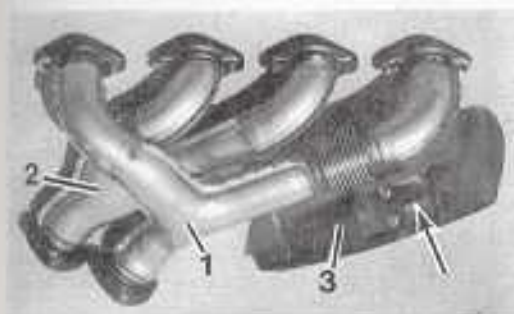
Photo 1

Fig. 1 - Exhaust Manifold Cylinders 1 and 4 Has new expansion element and modified flanges.

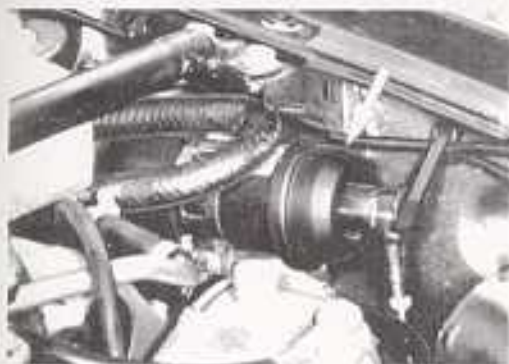
**Ignition coil left:** Terminal 1 and 15, High tension ignition lead term. 4

After performing any repairs on the engine, in the engine compartment, or near the central electric board, always check the following ignition wiring connections for tightness and good contact.

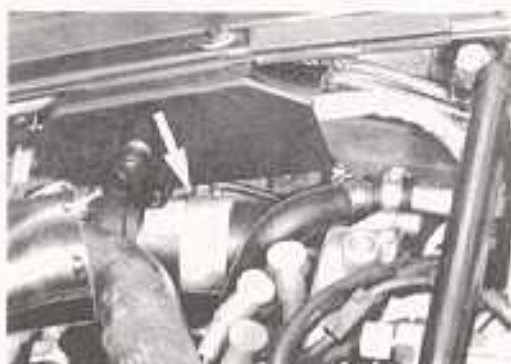
**Ignition coil right:** Terminal 1 and 15, High tension ignition lead term. 4

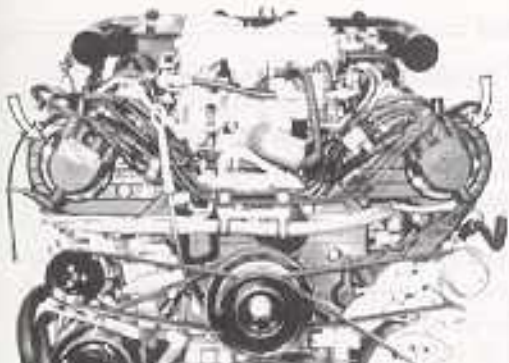
**Ignition Distributor left and right:** Distributor cap and ignition wire plugs.

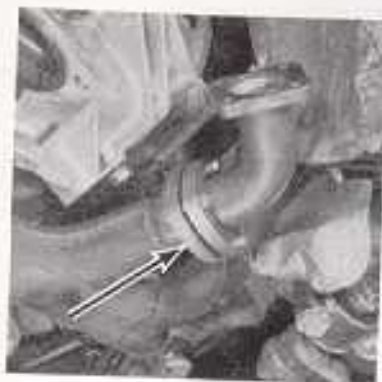
Rattles in the exhaust system can be caused by loose bolts in the three bolt flange connection (arrow).

If this condition is found, replace the bolts and nuts with the following parts:

Hex Bolt 900 074 267 02  
(three required)

Lock Nut 999 084 051 02  
(three required)

Tighten these bolts uniformly in several steps to a torque of 10+1 NM (7+.7 ft. lbs.).

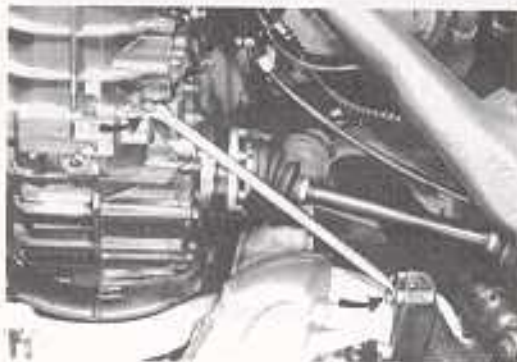
A support brace is installed between the transmission and the left side exhaust manifold (arrow in picture) to avoid noise from 2nd and 3rd gear while coasting at engine speed of 3000 to 4000 RPM.

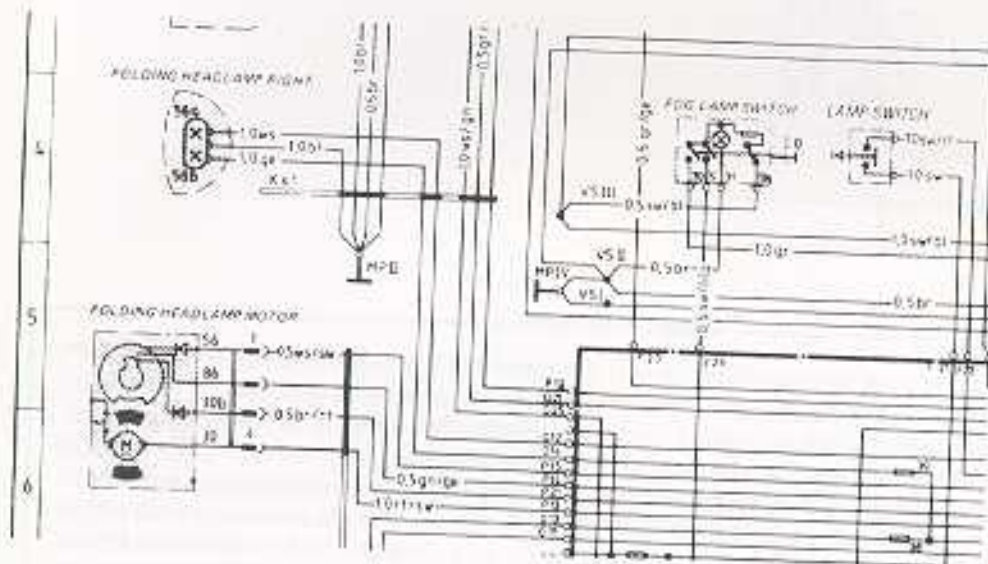
Correct designation is: Stop lamp switch

Please make corrections in Wiring Diagram  
Model 1986 Booklet and Workshop Manual  
928 Volume VI

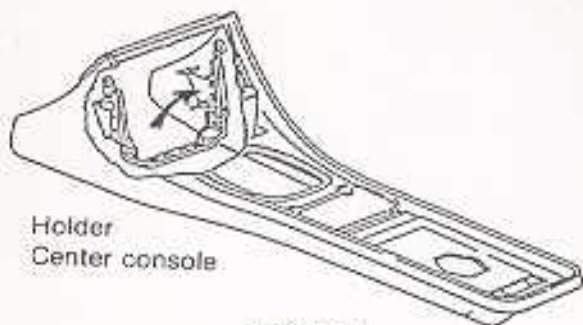
Picture 1

Holder  
Center console

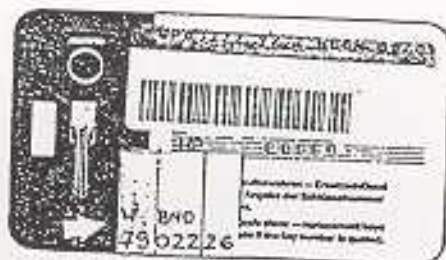
Picture 2

Key card

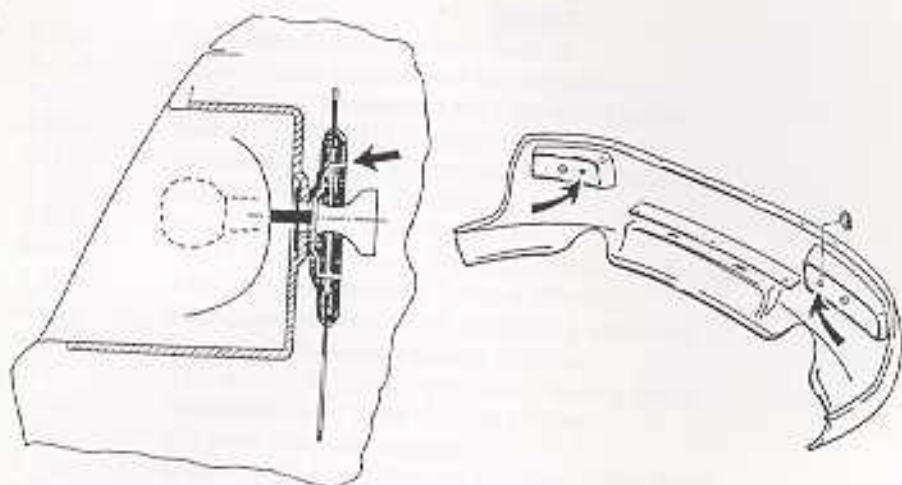
The foam rubber seal for the taillight screws was replaced with a plug-type grommet.

When repairing water leaks in the area of the taillights on cars prior to the above VIN, the foam rubber seal should be replaced with the plug-type grommet Part Number 999 703 066 50.
