PORSCHE

Service Information

Technical Bulletins

January 1988 - December 1988

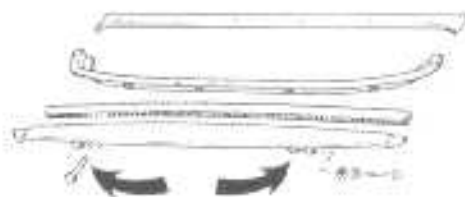
Figure 1

The sliding roof wind deflector angle is adjustable with two screws (Figure 1) to minimize wind noise.

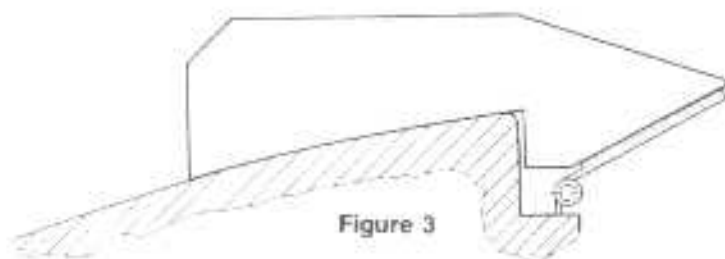
Figure 3

For basic adjustment an angle gauge can be fabricated out of cardboard, wood, or similar material according to attached templates (Figure 2). Align gauge as shown in Figure 3.

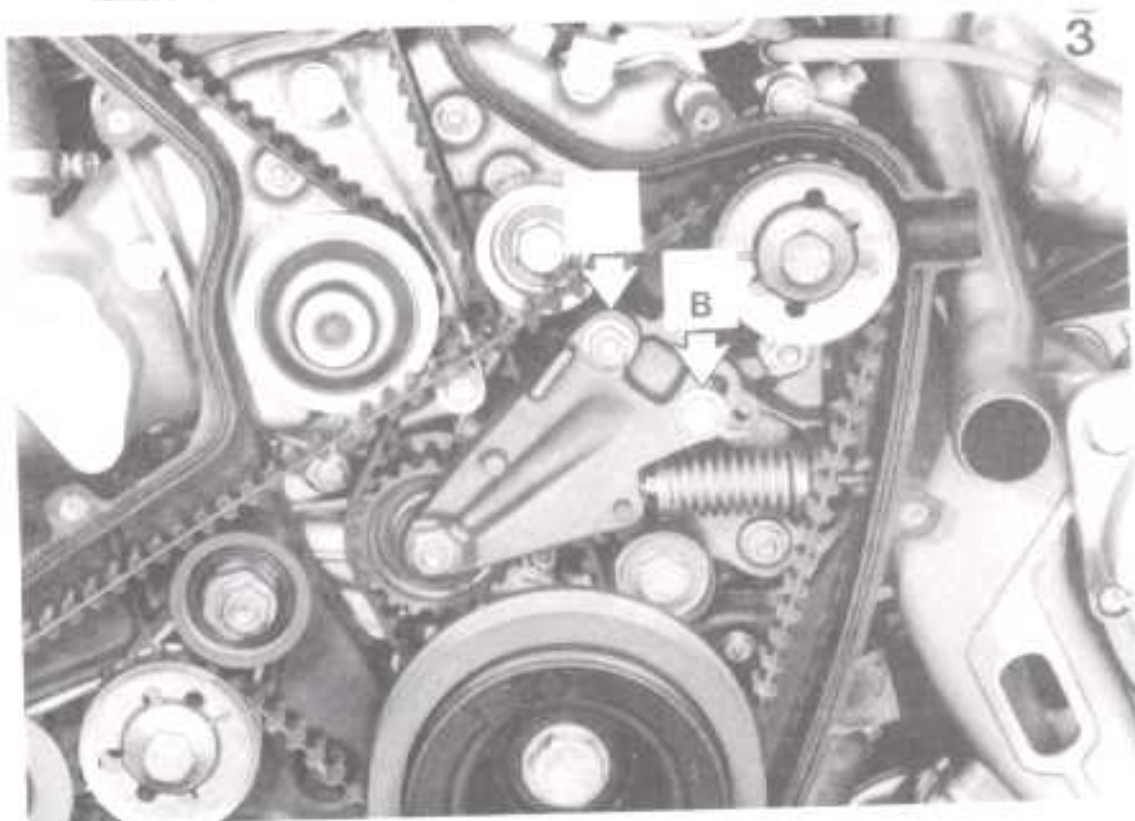
NOTE: On cars of Model Year 1987 up to engine No. 42H02372 it is possible that the tensioner adjusting area is not enough to slip the belt onto the camshaft drive gear. In these cases, remove the tensioner bolt M8x45 to loosen the tensioner more (photo #3, arrow B).

33. Loosen nut 'A' and bolt 'B' to tension the camshaft drive belt (photo #3). Then tighten bolt and nut.

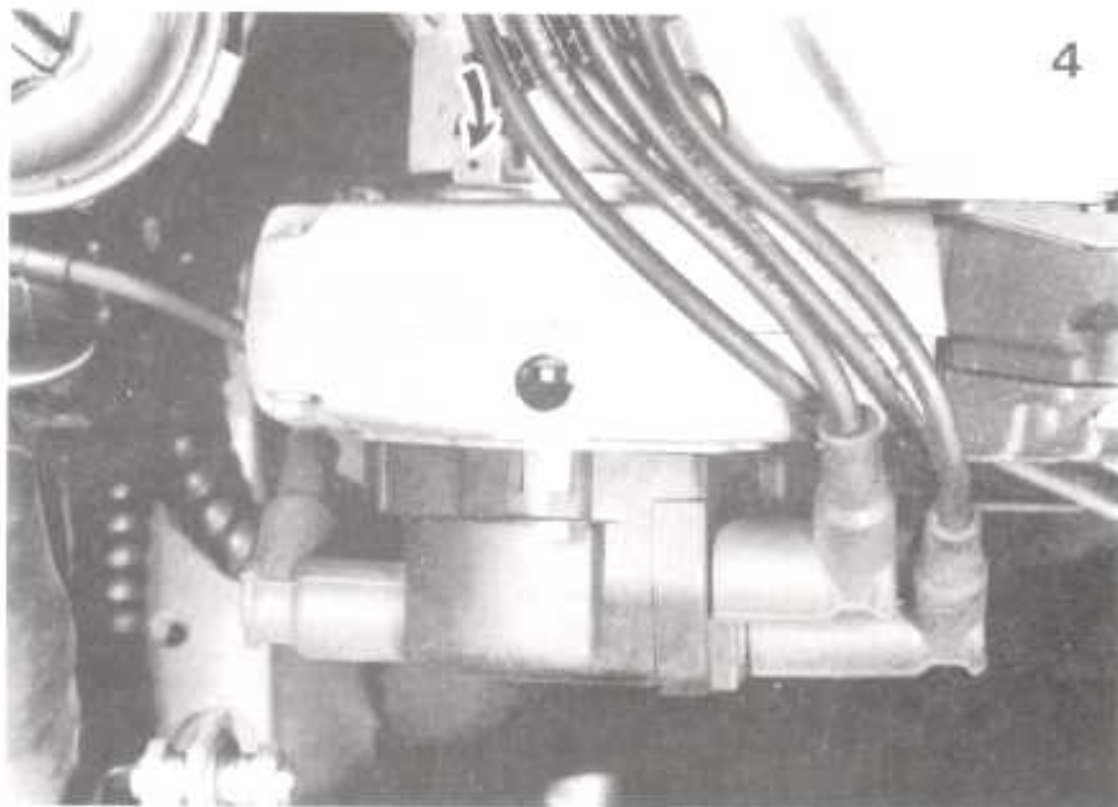
59. Mark top cam housing with center punch for identification purpose, that a new type belt was installed (see photo #4 — arrow);

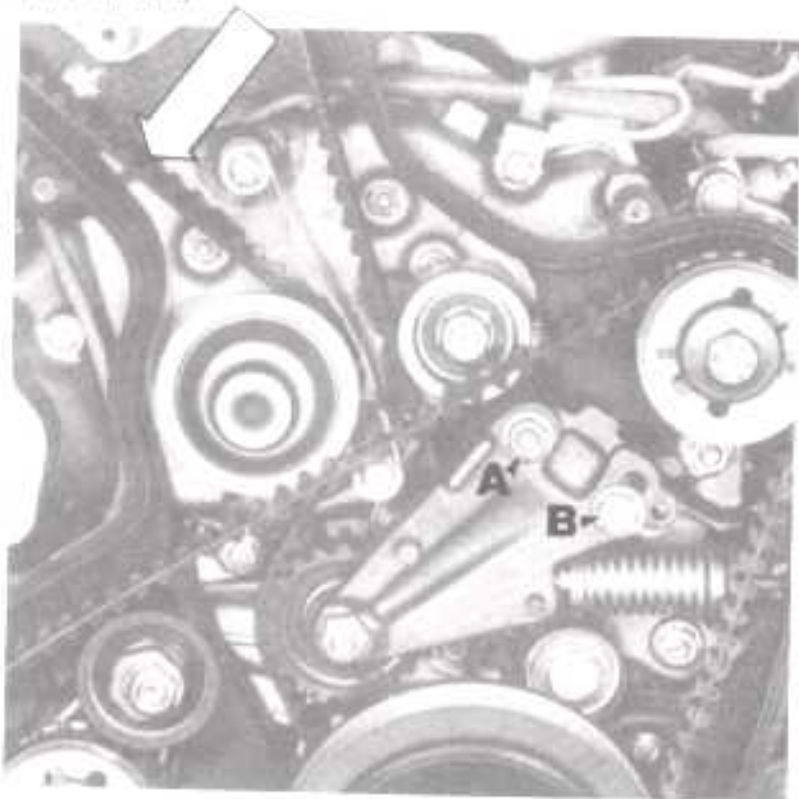
When adjusting the camshaft drive belt tension, from '87 Models on, it is important to ensure free movement of the belt idler pivot. After loosening nut A and bolt B, apply downward thumb pressure twice, pressing the cambelt against the belt cover in the area indicated (arrow).

Afterwards, retorque nut A and bolt B to 20 Nm (14 ft. lbs.)

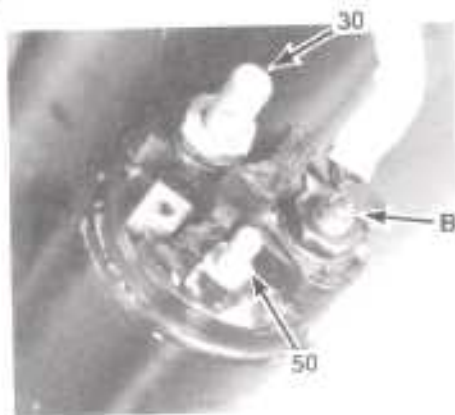
Fig. 1

Refer to figure 1. With a suitable jumper, bridge terminal 30 and terminal 50. Do not allow connections to touch chassis ground. If the starter runs, check the ignition/starter switch and terminal 50 path. Repair as necessary.

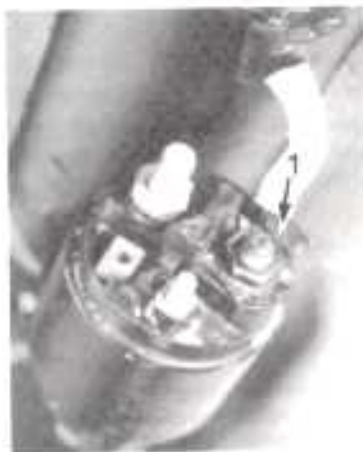
Fig. 2

1. Disconnect battery ground strap from the battery.
2. Remove wiring and positive cable from starter solenoid.
3. Disconnect starter motor cable (figure 2, arrow 1) from solenoid (MB Nut).

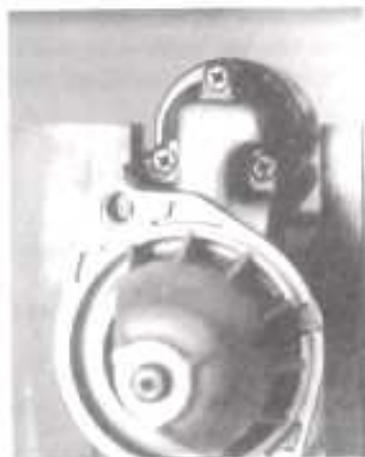
Fig. 3
(Starter Removed)

4. Remove the three **posi-drive** solenoid retaining screws (Fig. 3) and pull solenoid straight off.

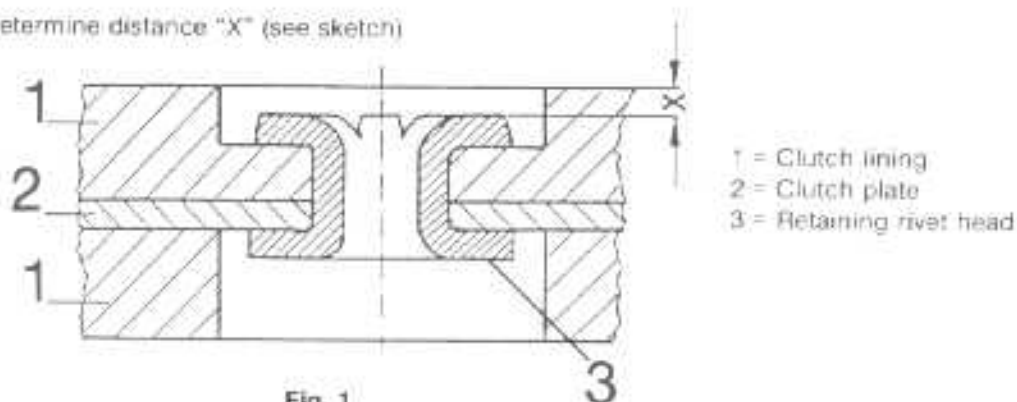
Fig. 1

Determine distance "X" (see sketch)

Measure from the clutch lining material (Fig. 1) to the retaining rivet. Be sure to measure only **opposite** the rivet head.

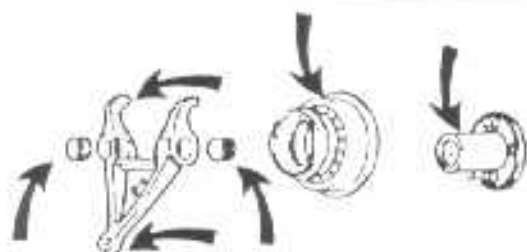
All 4 Cylinder

When making repairs in the area of the clutch, always use OIsta Longtime 3 EP grease, PN 000 043 024 00 to lubricate the parts in areas indicated by arrows.

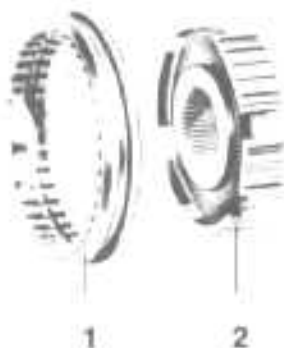
In case of complaints of jumping out of gear, always check the shift rod adjustment first.

Refer to Technical Bulletin Group 3, Number 8705, Book D, Page 140.

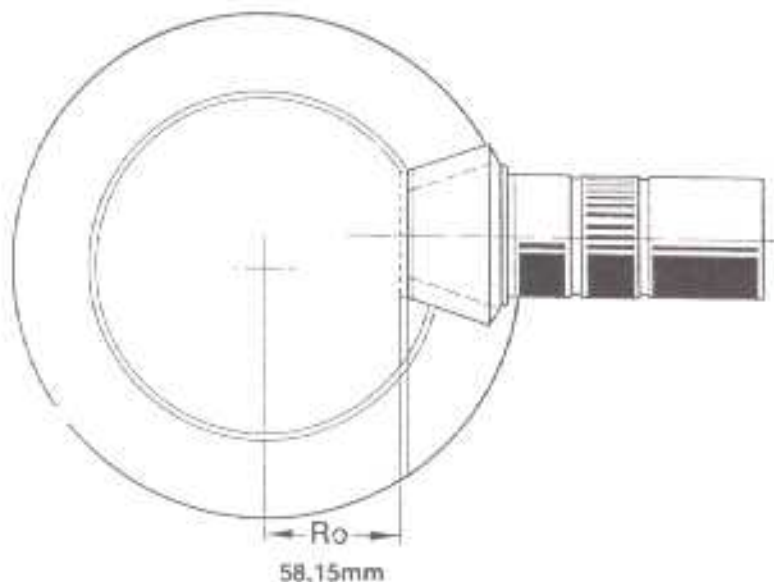
When adjusting the pinion depth of 944S manual transmissions type 083 D AGP or AGR, use the 'Ro' value of 58.15mm (see sketch)

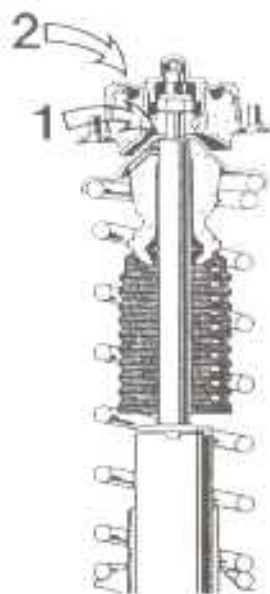
For Model Year 88, some cars received an additional washer, Part Number N 012 233 3, between the upper spring plate and strut mount (arrow 1). Cars with the additional washer can be recognized by a yellow paint dot on the upper strut mounting plate (arrow 2).

When repairing cars marked in this way, be certain to reinstall the additional washer, otherwise the spring plate may touch the upper strut mount resulting in a noise.

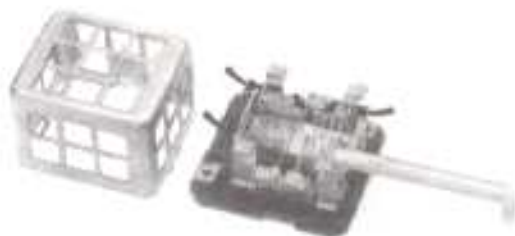
If the fresh air blower motor intermittently switches to high speed by itself, the bimetal temperature switch on the fan housing could be the cause.

To repair, remove the switch from the vehicle. Remove the cover and increase the gap by approximately 1 to 2mm. Using a screwdriver, bend all four coils away from the bimetal strip (picture).

Caution: Be careful not to damage the coils. The windings within each coil must not touch each other.

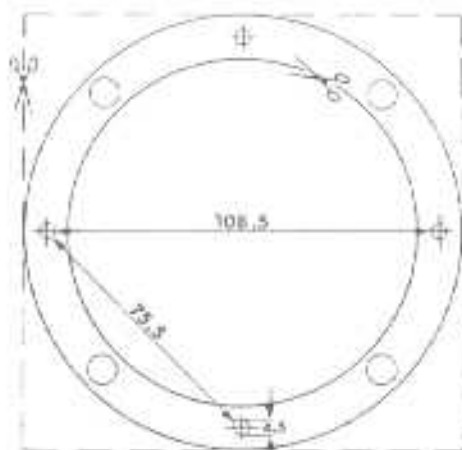
Figure 1

Door speakers that are broken in the area of the mounting screws can be repaired as follows:

Check hole distance (75.5mm and 108.5mm in Fig. 1) with a vernier caliper.
