**TECHNICAL BULLETINS**  
**JANUARY 1989 - DECEMBER 1989**

**SERVICE INFORMATION**  
PORSCHE CARS NORTH AMERICA, INC.

<b>Technical Bulletin</b>	<b>Model</b> 928 S4, 944S	<b>Group</b> 0
	<b>Part Identifier</b> 0300	<b>Number</b> 8901

**Subject: Performing System Adaption If Battery was Disconnected**

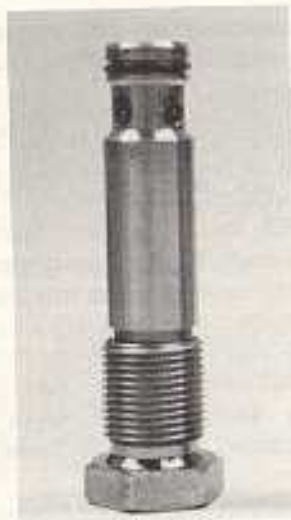
Fig. B

### Figure B Valve

- 1. Valve 944 107 035 01
- 2. O-Ring 944 107 935 01
- 3. Seal Ring N 043 815 3

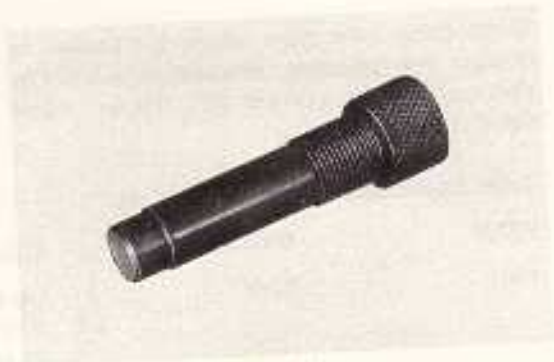
It is imperative that the oil cooler housing and the oil pressure relief valve bore in the engine block be perfectly aligned. If they are not, the oil pressure relief valve can be improperly loaded and may bind internally, causing excessively high or low oil pressure. Binding during removal of a misaligned one-piece pressure relief valve will cause the valve to come apart. If this occurs, the valve must not be reassembled and used. Instead, a new valve should be installed. This unit is considered a NON-servicable part and must not be disassembled.

Where valve PN 944 107 035 01 is to be installed, use special tool 9262/1 (this tool replaces special tool 9262).

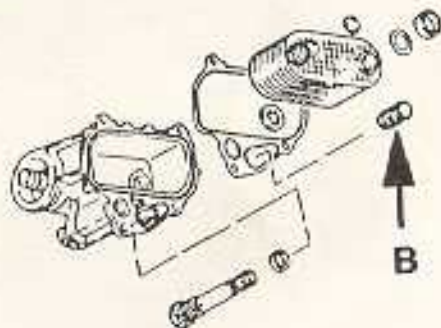
NOTE: Special tool 9215 is only used in engines having a steel sleeve installed in the oil pressure relief valve passage (1983-1986). It is important that the sleeve (arrow B below) be firmly installed in the crankcase. If loose, the oil cooler housing must be removed and the sleeve secured with loctite 648 or 638. Drive the sleeve to stop with special tool 9215. Consult the 944 Workshop Manual Vol. I, page 17-22 for additional instruction.

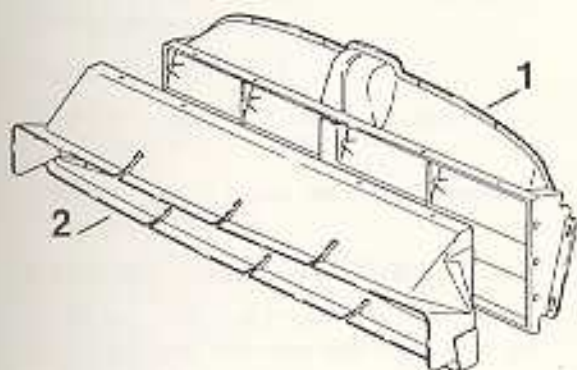
The cooling flaps (1 in figure) and the air duct (2 in figure) are now available as separate parts.

Cooling flaps	PN 928 575 951 00
Air duct	PN 928 575 521 00
Complete 1 & 2	PN 928 575 051 00

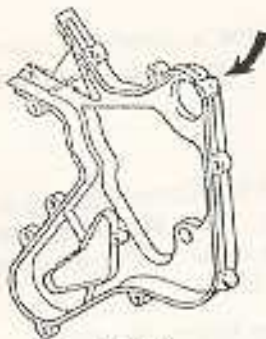
Fig. 4

The rear part of the toothed belt cover PN 944 105 039 01, applicable to 87/88 models is superseded by belt cover PN 944 105 039 02. With this cover, the opening (Fig. 4) is closed off.

When repairing, no attempt should be made to open the closure.

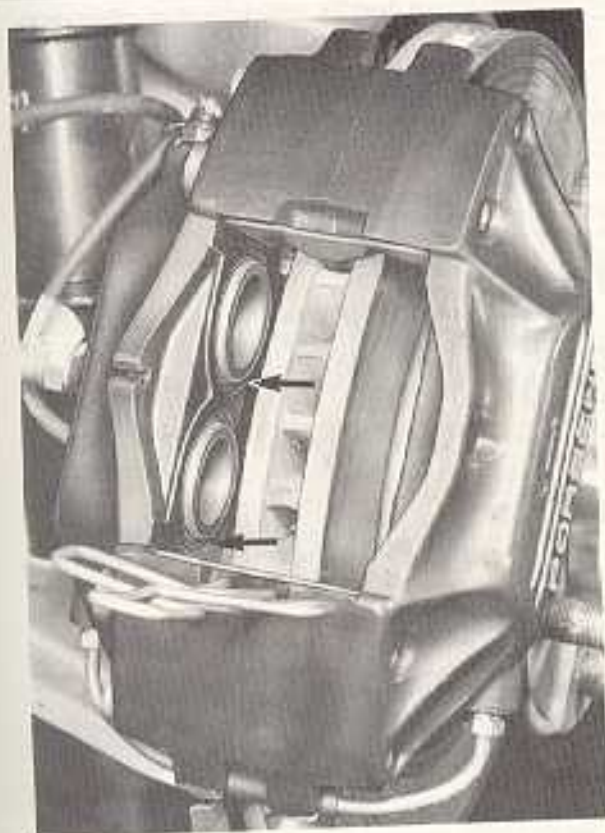
The front and rear brake calipers of the 944 S2, 944 Turbo, and 928 S4 for Model 89 received modifications in the area of the pistons and dust seals (now similar to the two piston calipers). Refer to the chart below for identification.

Replacement and repair procedures are different for each type of caliper and are detailed on the following pages.
